21 August 2024

PROJECT: TOM MITCHELL DAM PROPOSED UPGRADING AND BETTERMENT WORKS, DISTRICT OF VHEMBE, LIMPOPO PROVINCE

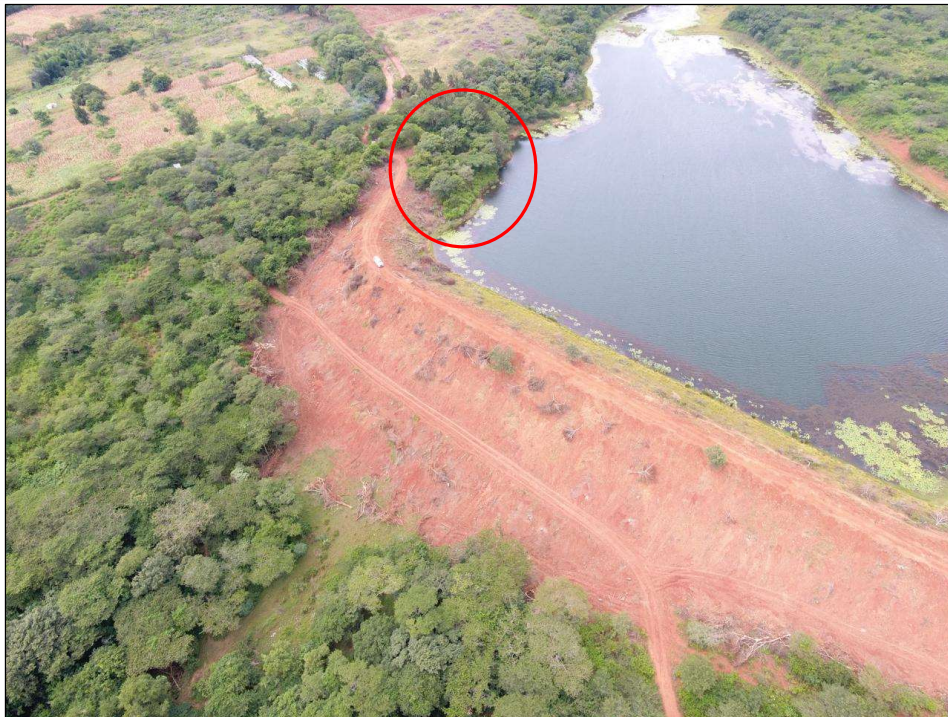
Unfortunately, due to time constraint and steep upstream slope near the right bank, a few large trees were left on the upstream slope as indicated in **Figure 1** below. These trees should still be cut, treated, and removed. The contractor to be appointed should take note of the relatively steep upstream slope in that area which makes proper access by machines difficult and should compensate for that.

Figure 1: Remaining trees to be removed

The trees should be cut in manageable pieces and should be disposed at a site as agreed with the community leader where the community will have easy access to utilize the wood.

The cut tree stumps should be treated with an anti-regrowth agent, approved by the Engineer.

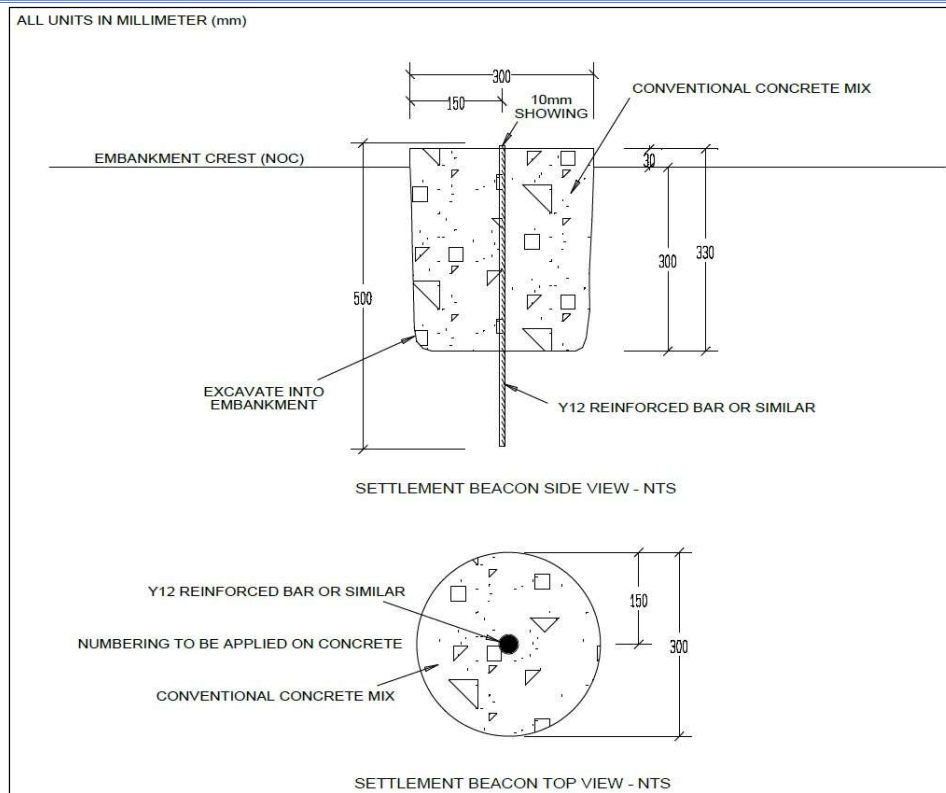
Remains of settlement beacons previously installed on the dam wall crest section, at approximately 50m intervals, were found during the dam safety inspection conducted. Unfortunately, during the recent clearing of the dam wall most of these beacons have been damaged as the contractor was not aware of them. Subsequently the beacons (except for one "SB3") could not be surveyed for settlement purposes.

Figure 2: Schematic of a settlement beacon

It is recommended that the settlement beacons on the crest shall be reinstated.

A number of ten (10) settlement beacons need to be reinstalled and numbered following the specifications and details provided in **Figure 2** below.

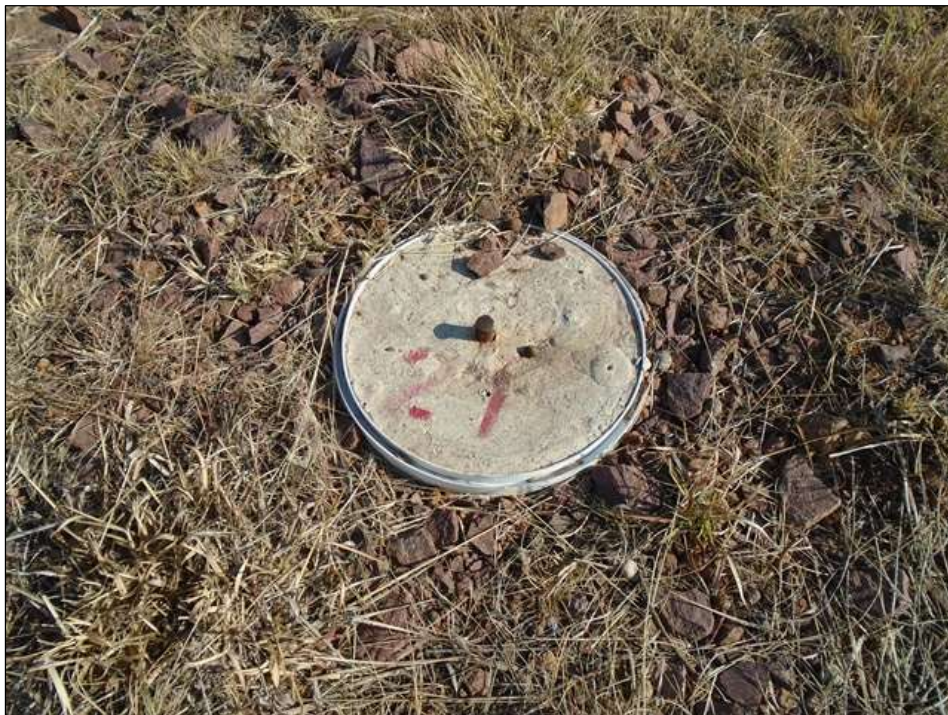
Figure 3: Settlement beacon typical example

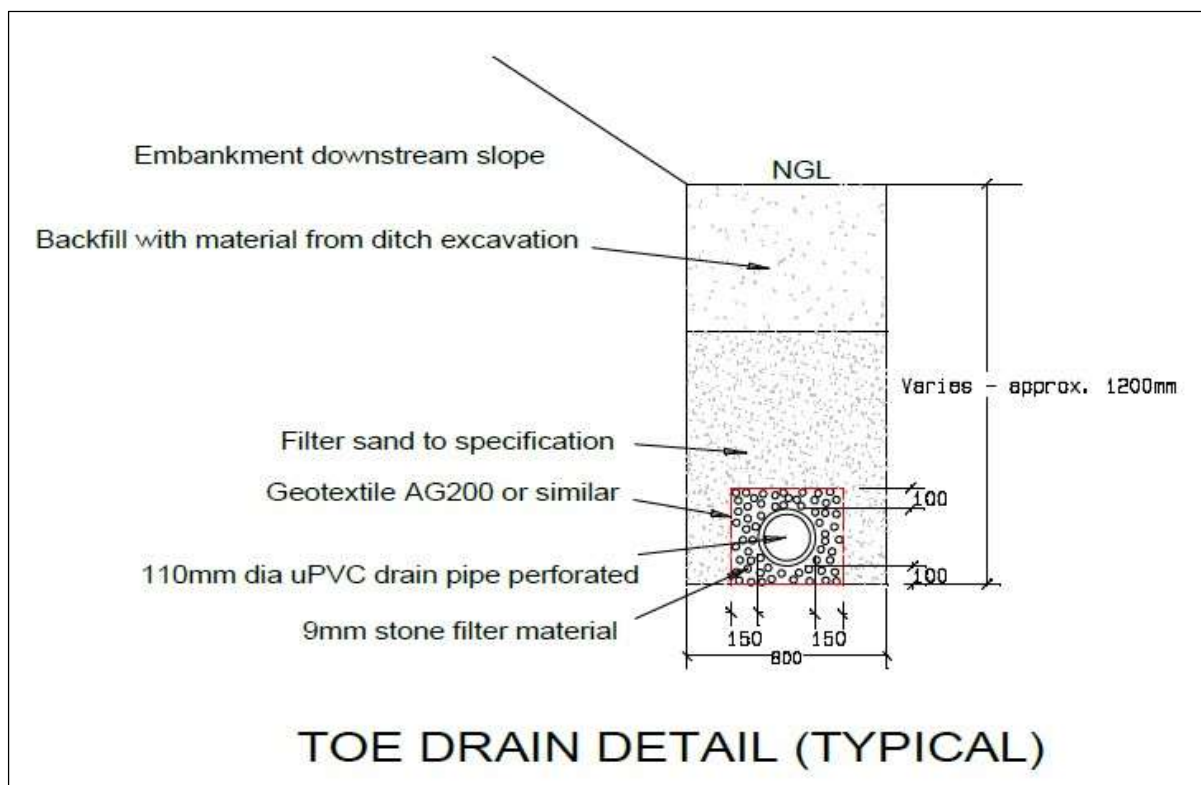
The rock drainage system is still expected to function as designed and constructed for. However, the wet conditions observed at the toe line during the clearing of the vegetation is of concern. It is therefore concluded that the existing rock toe drains might not be sufficient and should be augmented by the installation of additional toe drains.

Figure 4: Schematic of a toe drain cross section

The anticipated new toe drains length is measured as 140m. The toe drains will comprise of 110mm dia slotted Drainex drainpipes surrounded with 9mm stone and wrapped in AG200 bidim or similar approved. The drains will be installed within excavated trenches which is filled with approved graded filter sand. Refer to **Figure 4** below for detail.

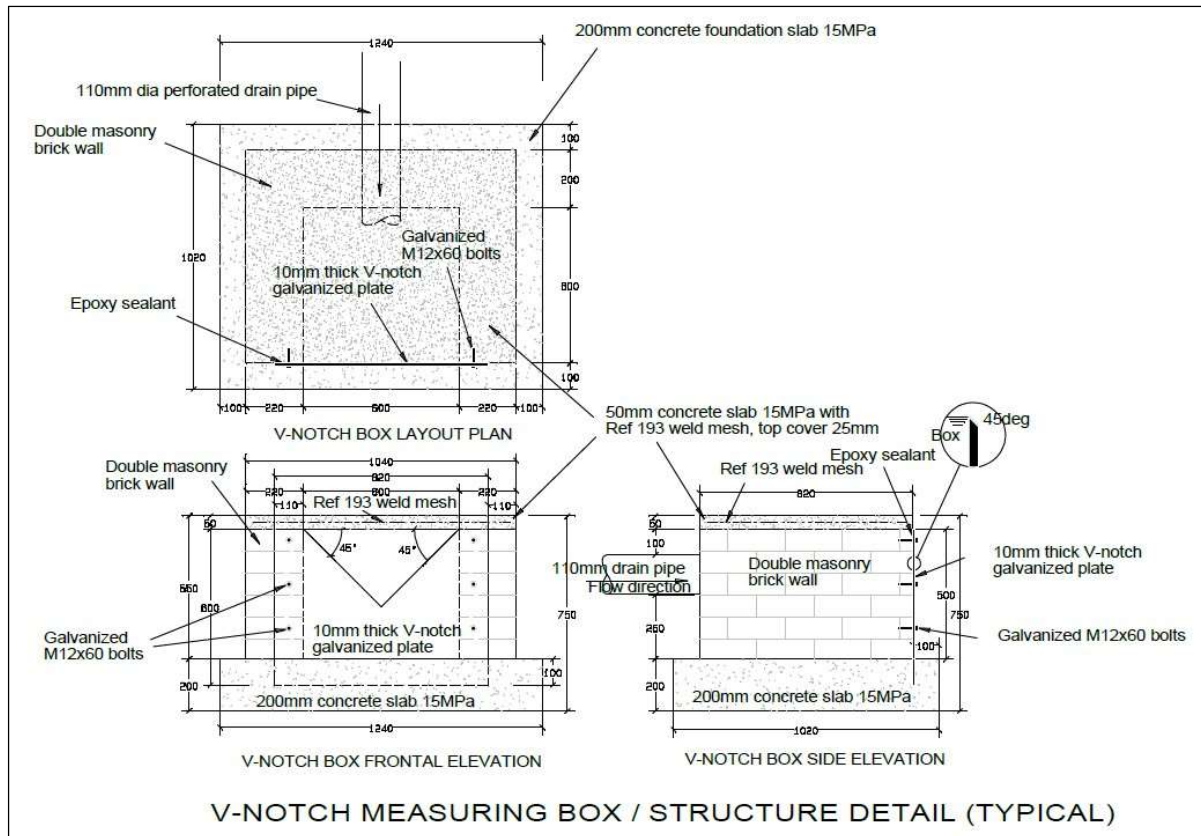
Figure 5: Schematic of a V-notch measuring structure

In addition, a proper V-notch measuring structure should also be constructed in order to manage and record the seepage on a regular basis.

The two toe drains will join at the deepest end at a V-notch measuring structure where seepage can be monitored and controlled. The details of the V-notch structure are presented in **Figure 5** below.

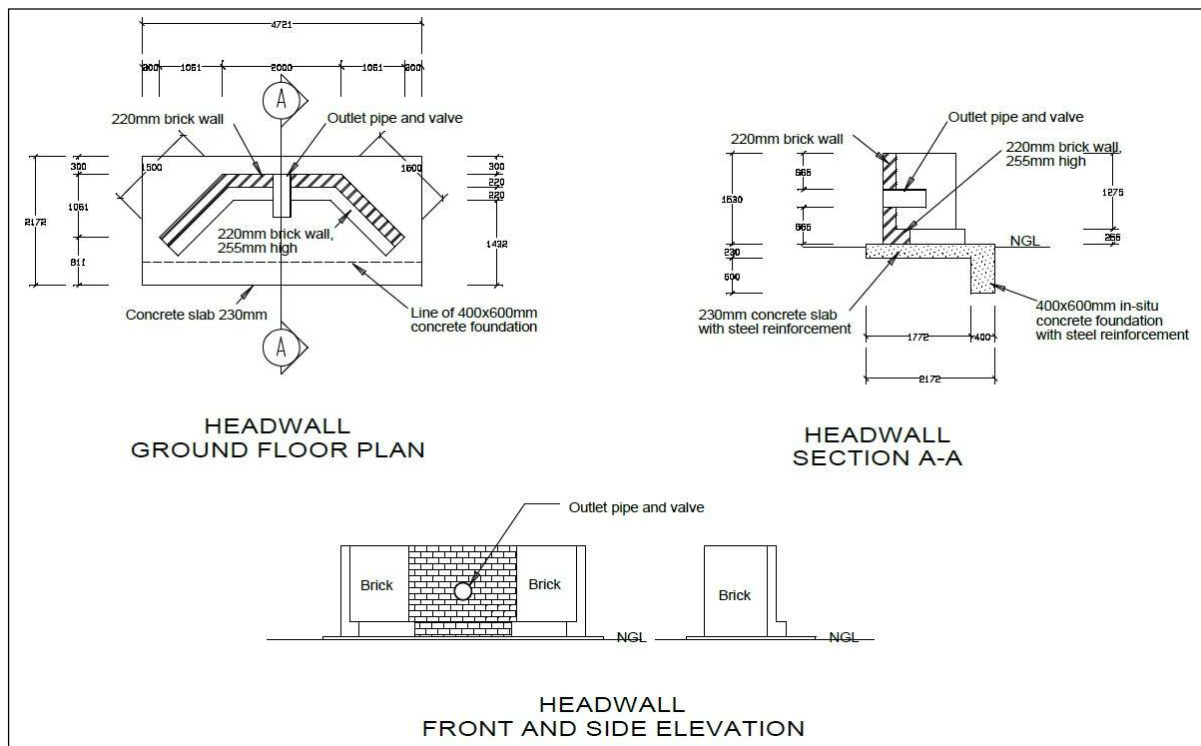
The outlet works are non-functional and out of commission and the upstream sluice gates appear to be in the closed position to avoid discharge from the dam.

Figure 6: Schematic of an outlet pipe headwall structure

- Refurbishment of the two upstream sluice gates (divers will be required). If the sluice gates are too damaged to be refurbished it should be replaced.
- Installation of two new stainless-steel raising spindles against upstream slope, anchored with brackets to the existing concrete casted inclined beams.
- Installation of two stainless-steel handwheels on the crest section.
- Safeguarding / securing of handwheel controls on the crest.
- Construction of two brick masonry headwalls where the two outlet pipes exit on the downstream slope side. Refer to **Figure 6** below for headwall details.
- Installation of two 400mm dia gate valves on the downstream side at the headwalls.
