## **PROJECT: WILLIE VAN WYK DAM PROPOSED UPGRADING AND BETTERMENT WORKS, DISTRICT OF VHEMBE, LIMPOPO PROVINCE**

## **2. Proposed betterment and upgrading works**

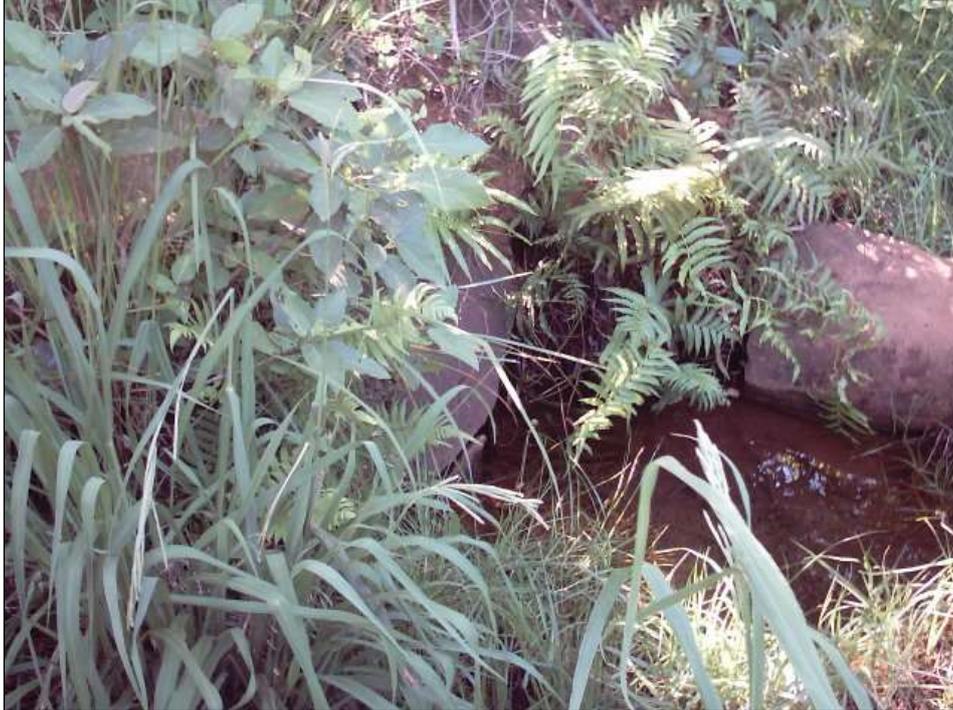
**Figure 5: Eye of the spring**

A spring near the left abutment is present. According to locals the spring was there since even before the dam was built. It is recommended that the water flowing from the spring shall be formally channelled and released at a safe place and distance downstream of the dam to avoid wet ponding and saturated areas.

A properly excavated and formed earth channel will suffice. Refer to **Figure 5** below showing the eye of the spring.

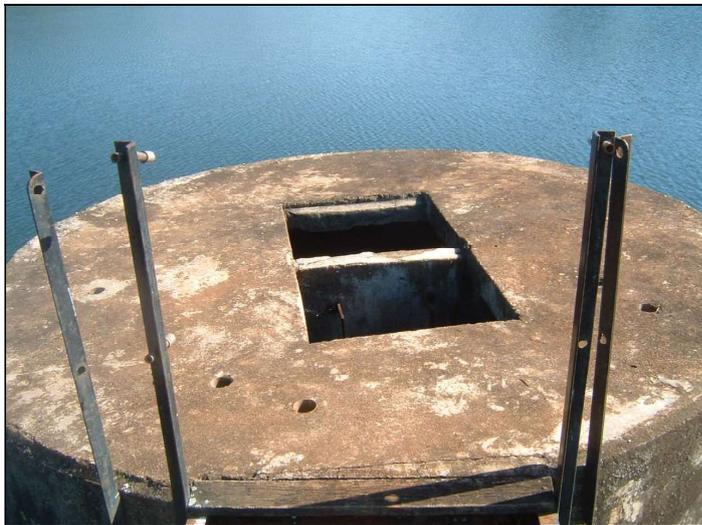
Photo 11  
Top of inlet tower

Note the missing hand-  
rail and manhole covers

- a) Reinstall a new handrailing on top of the intake tower.
- b) Install step irons to the outer side of the intake tower to access the tower from a boat.
- c) Refurbish the four 200mm gate valves within the tower.
- d) Refurbish and paint the pipework with an anti-rust medium.
- e) Refurbish the cad ladder in the tower.
- f) Replace the tower access cover plate on top of the tower. Cover plate to be galvanized.
- g) Construction of two brick masonry headwalls. One at the 250mm dia outlet pipe for water releases, and one at the 750mm dia pipe for flood discharge. Refer to **Figure 4** below for headwall details.
- h) Installation of a 250mm dia gate valve on the downstream side at the new headwall.

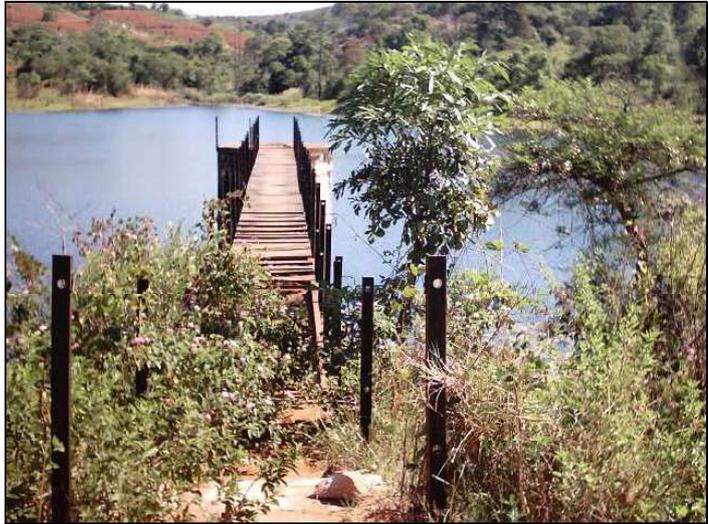
Photo 14  
View of access bridge

No access to the tower was possible and assumptions based on previous reports were adopted. Since the second inspection, the bridge from the crest to the tower had been totally removed. As a result of this the current state of the outlet works and tower structure could not be inspected / evaluated. However, it is assumed that the pipe works and valves are in urgent need of refurbishment.

With regard to access to the intake tower, the walkway / access bridge from the crest is not going to be reinstated as part of the betterment works due to the risk of being vandalized again and security reasons. New access will be provided by means of step irons which will be fixed to the inlet tower. Access in the future will be by means of a boat. All valves will be in a closed position.

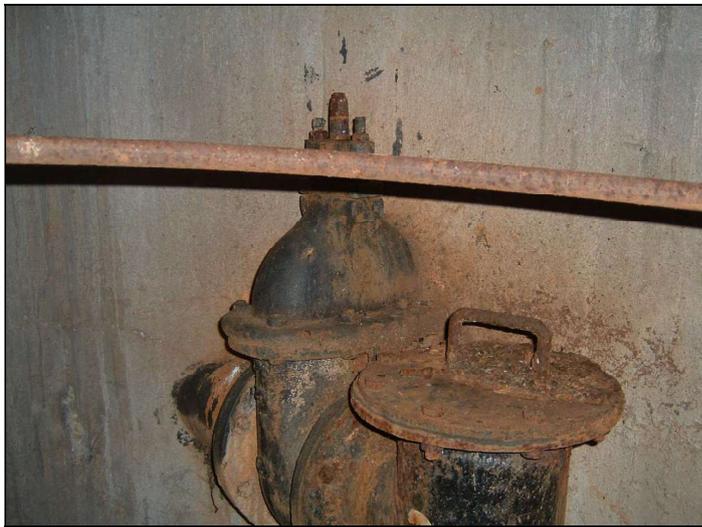
Photo 17  
Rusted valves inside  
the tower

The old outlet works appear to be damaged and out of commission. The intake gate valves in the tower appear to be in a closed position to avoid discharge from the dam. There is currently no downstream closing mechanism on the 125mm dia outlet pipe.
