## **PROJECT: WILLIE VAN WYK DAM PROPOSED UPGRADING AND BETTERMENT WORKS, DISTRICT OF VHEMBE, LIMPOPO PROVINCE**

## **2. Proposed betterment and upgrading works**

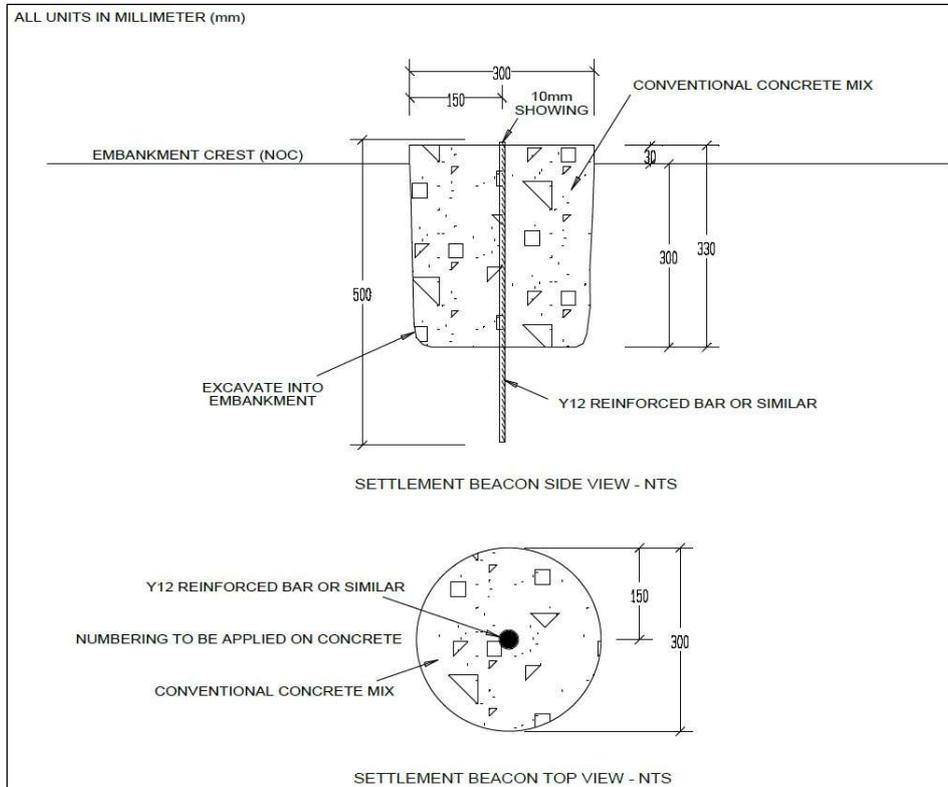
**Figure 1: Schematic of a settlement beacon**

There are currently no settlement beacons on the dam wall crest. With reference to this it is recommended that settlement beacons shall be reinstated / installed on the crest section at 40m intervals for future dam safety reference.

A number of seven (7) settlement beacons need to be reinstated and numbered following the specifications and details provided in **Figure 1** below.

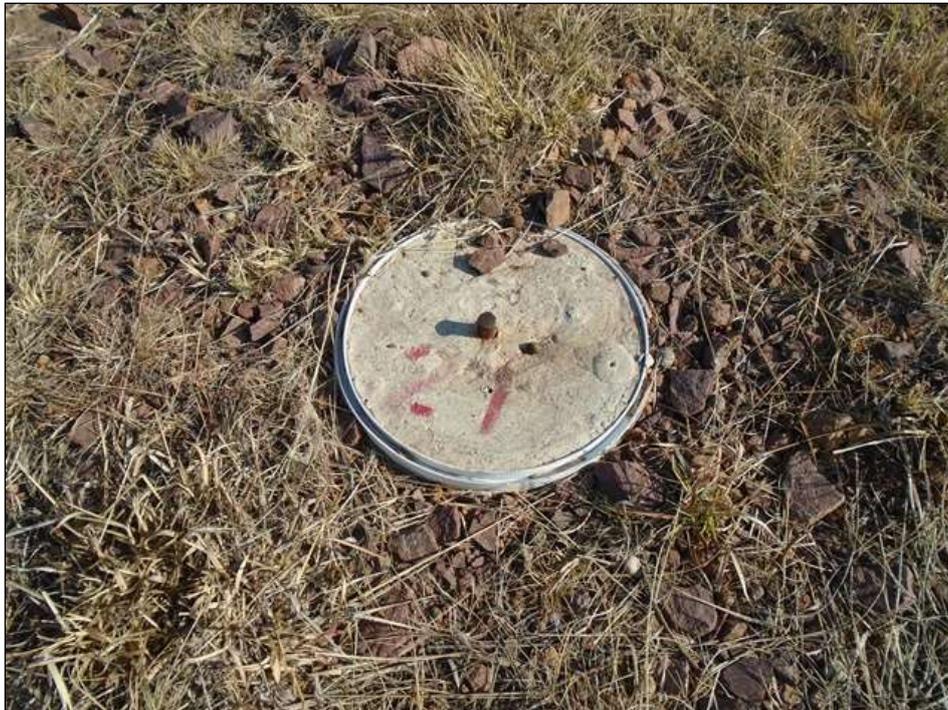
**Figure 2: Settlement beacon typical example**

**Figure 2** below shows a typical installed settlement beacon.

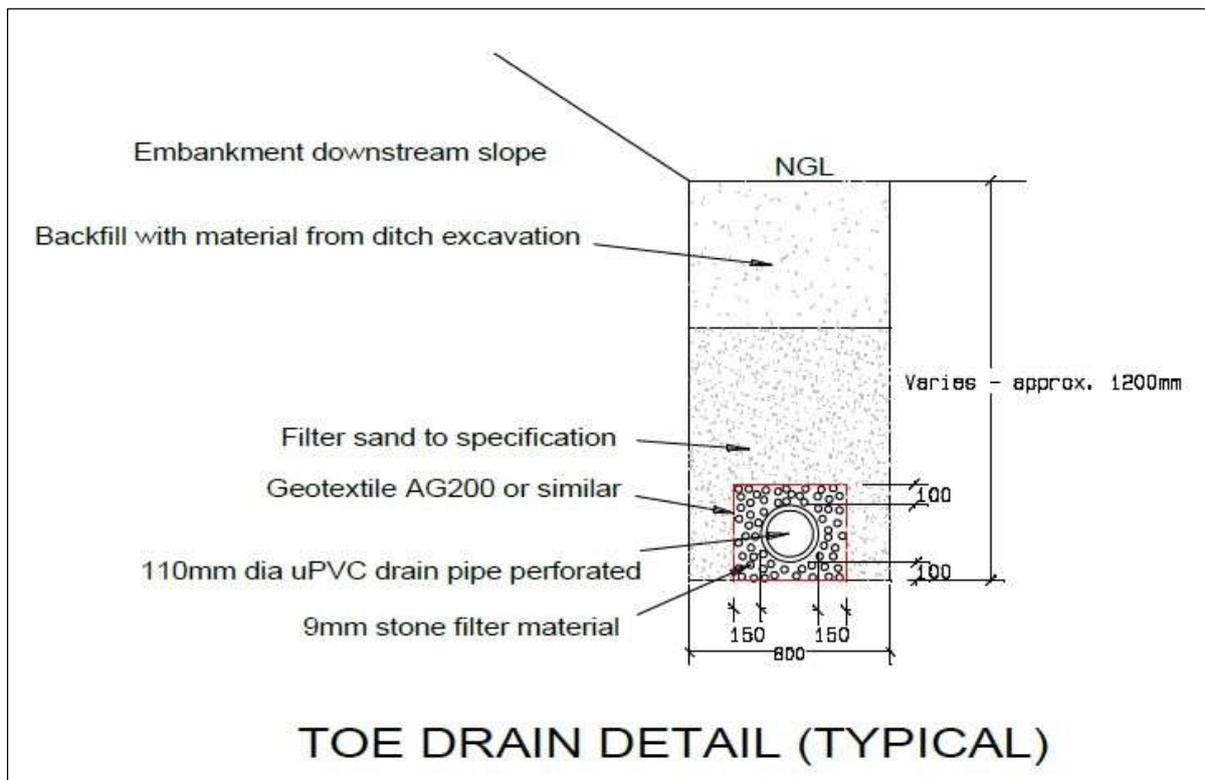
Figure 3: Schematic of a toe drain cross section

The installed toe drain system appears to be non-functional and blocked and needs to be replaced. Standing water was visible within the manhole. It is therefore recommended to install new toe drains with v-notch measuring structure in order to manage, control, and record future seepage. (Refer to Betterment Works & Upgrading Document attached for detail).

The anticipated new toe drains length is measured as 140m (i.e., 80m on the western side and 60m on the eastern side). The toe drains will comprise of 110mm dia slotted Drainex drainpipes surrounded with 9mm stone and wrapped in AG200 bidim or similar approved. The drains will be installed within excavated trenches which is filled with approved graded filter sand. Refer to **Figure 3** below for detail.

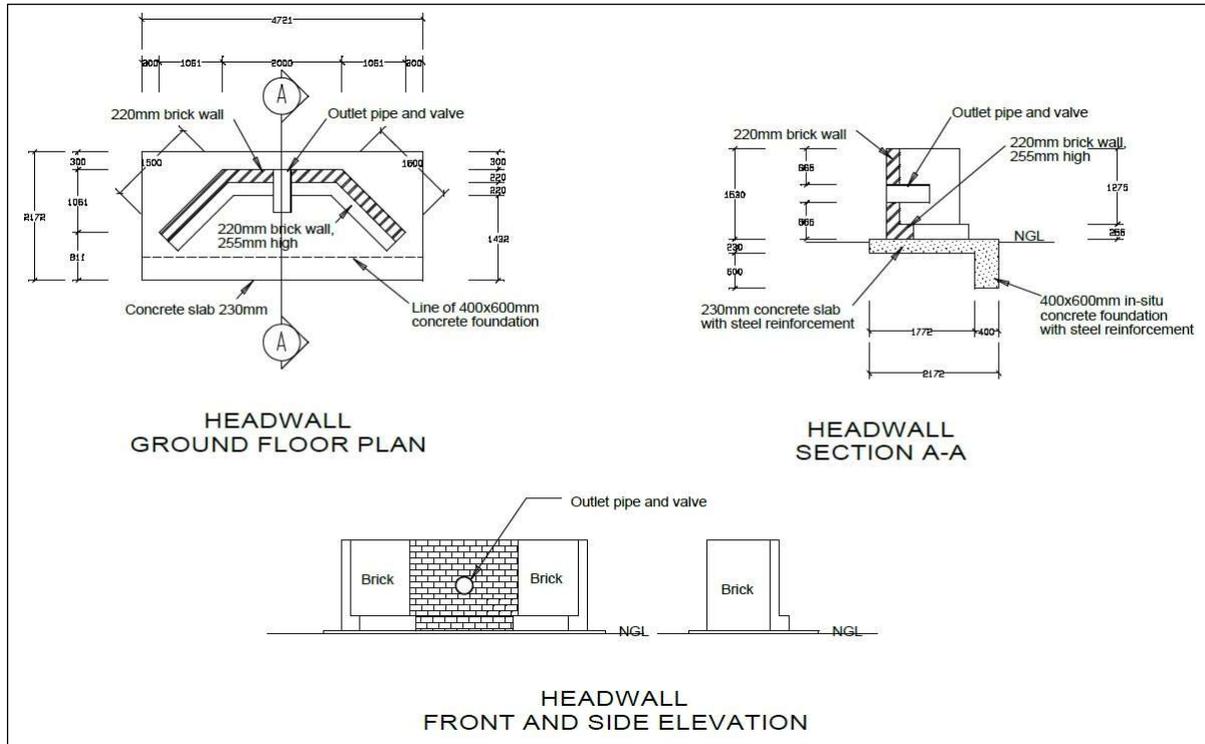
Figure 4: Schematic of an outlet pipe headwall structure

The old outlet works appear to be damaged and out of commission. The intake gate valves in the tower appear to be in a closed position to avoid discharge from the dam. There is currently no downstream closing mechanism on the 125mm dia outlet pipe.

- a) Reinstall a new handrailing on top of the intake tower.
- b) Install step irons to the outer side of the intake tower to access the tower from a boat.
- c) Refurbish the four 200mm gate valves within the tower.
- d) Refurbish and paint the pipework with an anti-rust medium.
- e) Refurbish the cad ladder in the tower.
- f) Replace the tower access cover plate on top of the tower. Cover plate to be galvanized.
- g) Construction of two brick masonry headwalls. One at the 250mm dia outlet pipe for water releases, and one at the 750mm dia pipe for flood discharge. Refer to **Figure 4** below for headwall details.
- h) Installation of a 250mm dia gate valve on the downstream side at the new headwall.
